REHABILITATION AND STRENGTHENING OF
BURLINGTON NORTHERN SANTA FE RAILWAY
BRIDGE 482.1 OVER THE MISSISSIPPI RIVER
MEMPHIS, TENNESSEE

John W. Hronek & Ron G. Berry
HNTB Companies
1201 Walnut, Suite 700
Kansas City, Missouri 64106
Phone - 816-472-1201
Fax - 816-472-5013
September 2000

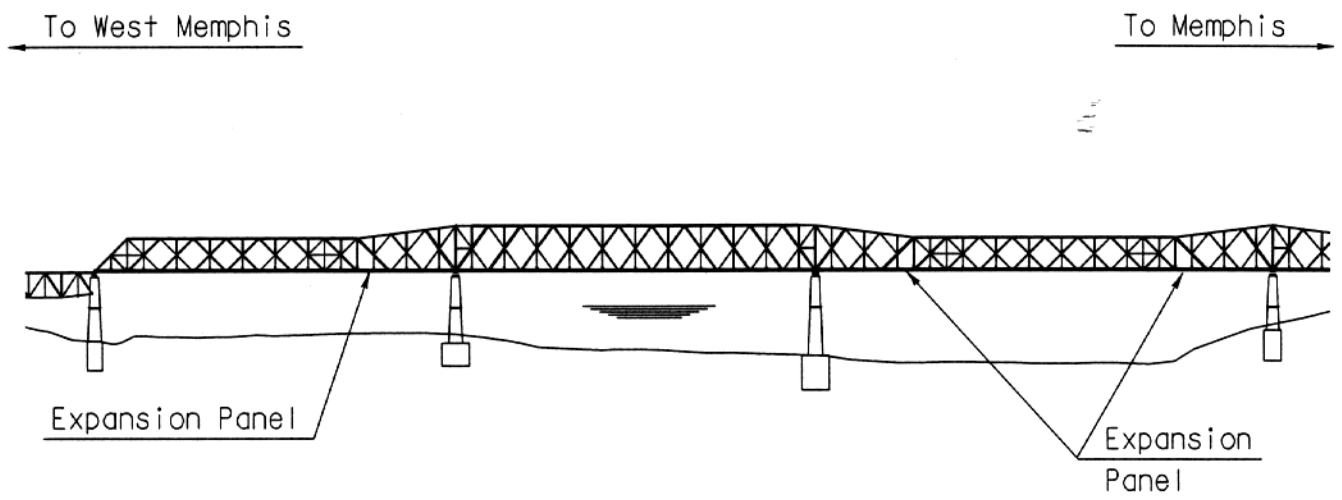
Figure 1. Elevation of Bridge 482.1

There are three expansion joints in the truss spans located at the ends of the cantilevered spans (two in the south cantilever spans and one at the south end of the north cantilever span). See Figure 1 for the location of the joints. The original plans detail the expansion assembly as a link-pin arrangement framed to the expansion panel stringers. The three joints deteriorated due to corrosion and mechanical wear. The expansion stringer in the last panel of the cantilever arms of the truss spans and adjacent to the suspended spans was out of level with the stub brackets attached to the floorbeam. The stringer span was about 3/4 to 1 inch low at these locations.
